Roofing/Flashings/ Chimneys

INTRODUCTION

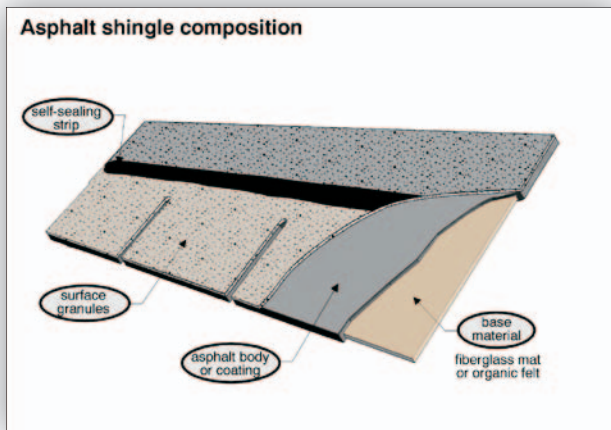
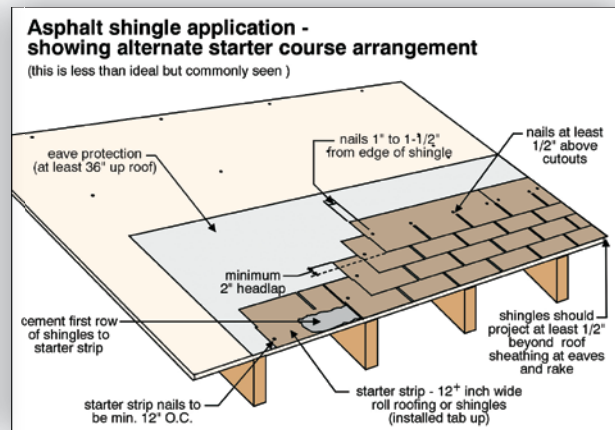
DESCRIPTION Asphalt shingles (also called composition shingles) are the most common roofing material used today. The shingles consist of asphalt-impregnated felt paper or glass fiber mats, coated with a layer of asphalt and covered with granular material.

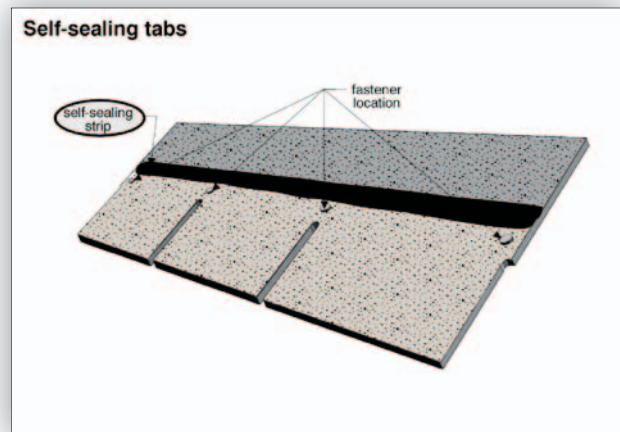
SELF-SEALING SHINGLES Most asphalt shingles have self-sealing strips, a strip of asphalt running across the middle of the shingle. The shingle above overlaps the lower shingle, with the bottom edge covering this strip. When the sun warms the roof surface, the two shingles stick together. This protects the shingles from being blown off in a heavy wind. Shingles installed in cold weather do not seal themselves until the weather warms up. They are vulnerable to wind damage during this period.

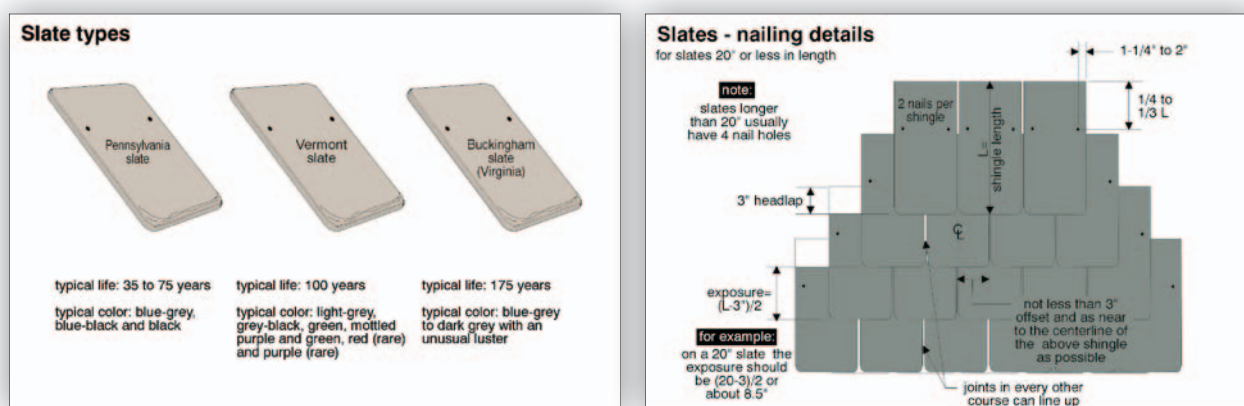
WEAR FACTORS While some slates are of low quality and tend to flake and shale, the biggest problem with slate roofs is often the nails holding the slates in place. With time, the nails rust and allow the slates to slide out of position. Copper and stainless steel nails last longer than galvanized nails. Once one slate has come loose, water rusts the nails holding nearby slates in place. Good maintenance is important on an older slate roof. While it is not common practice, slate roofs should be inspected and repaired at least annually. Slates that have slipped are re-secured, and slates that have cracked or split as a result of mechanical damage are replaced. As a general rule, roof replacement makes sense when more than 10% is in need of repair.

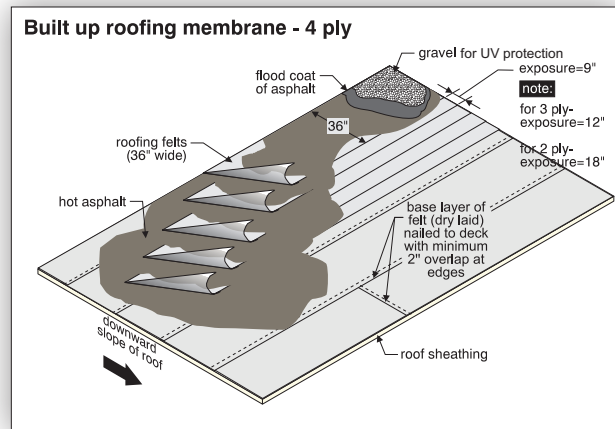
DESCRIPTION Built-up roofs are commonly called tar-and-gravel roofs, even though most modern systems use asphalt instead of tar. They are a multi-ply roofing system, consisting of two, three, four or even five plies of roofing felts with a mopping (coating) of asphalt between layers. A flood coat of asphalt is then applied over the top and covered with gravel to reflect ultraviolet light and protect the roof from mechanical damage. These roofs are still common commercially, but are being replaced residentially with newer systems that are faster and easier to install.

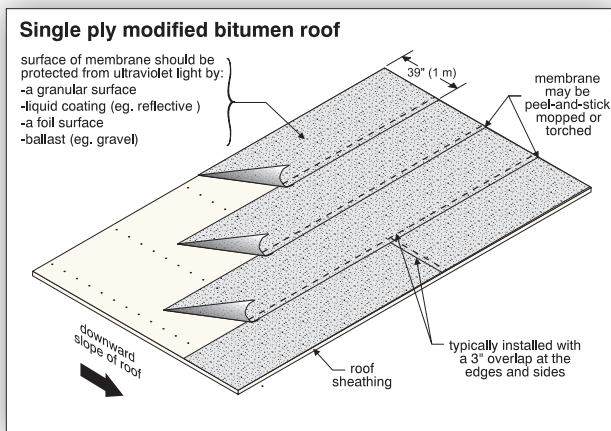
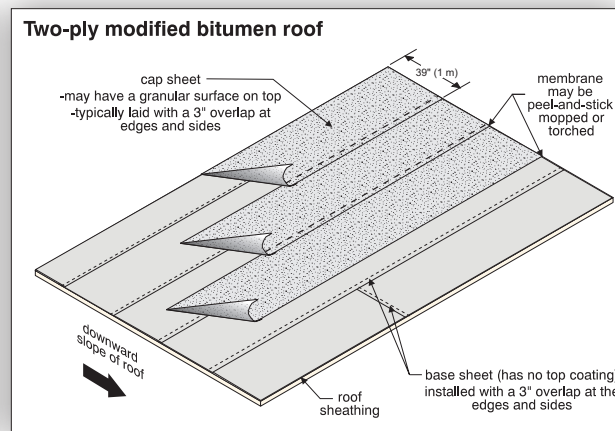
DESCRIPTION Modified bitumen membranes are an alternative to built-up roofs. Polymer-modified asphalt is bonded to fiberglass or polyester reinforcing to form sheets of roofing membrane. Rolls of this rubberized asphalt membrane are typically torched onto the roof, bonded (mopped in) to the roof with hot asphalt, or adhered to the roof using a peel-and-stick backing. The surface of the membrane may be protected from ultraviolet rays by a coating of granules, foil, or paint. The sheets are approximately 40 inches wide and usually overlap each other by four inches. Modified bitumen roofs may be installed as either a single or double layer system.

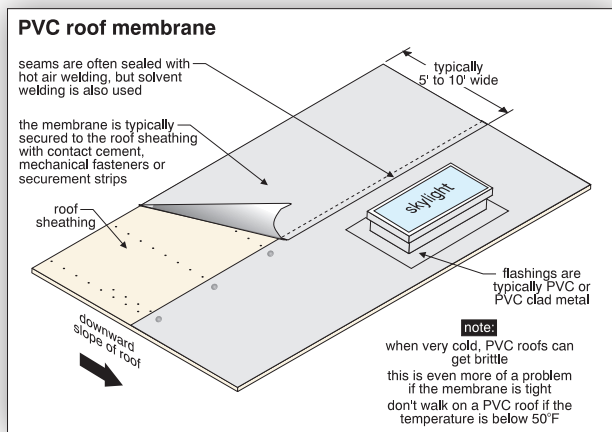
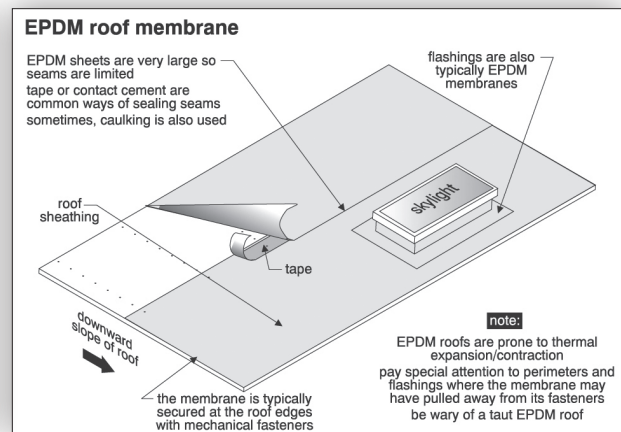
Plastic, or thermoplastic, membranes include polyvinyl chloride (PVC) and thermoplastic polyolefin (TPO). Rubber or thermoset membranes include ethylene propylene diene monomer (EPDM) and butyl rubber (polyisobutylene – PIB).

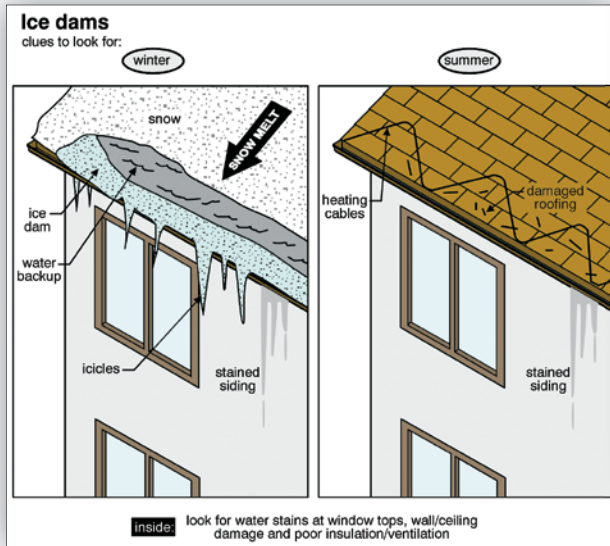
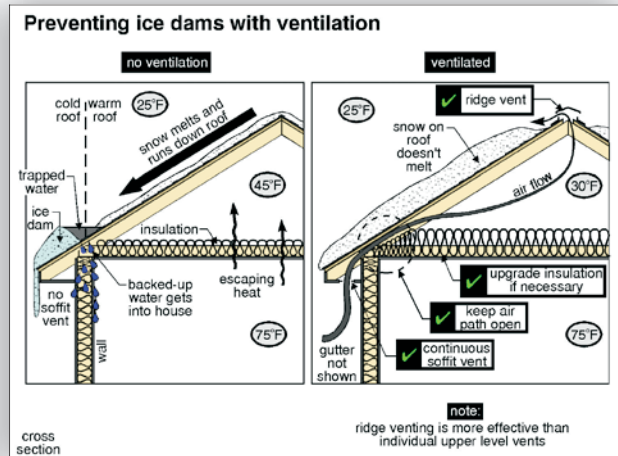
Ice damming problems do not necessarily occur every winter. They normally occur after periods of heavy snowfall when daytime temperatures are at or slightly above freezing while nighttime temperatures are below freezing.

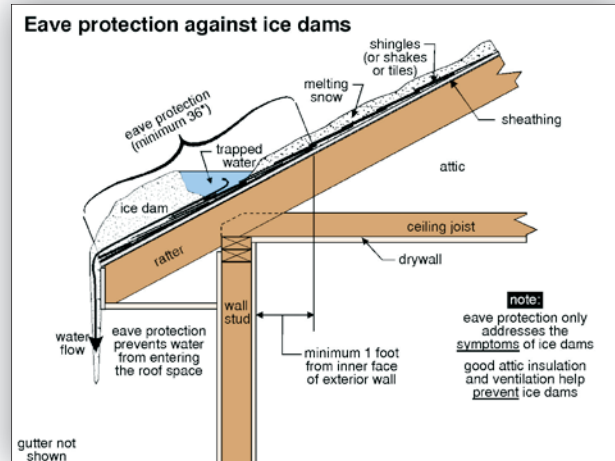
EAVE PROTECTION When re-roofing, eave protection should be provided along the lower part of the roof, from the edge up to roughly two feet beyond the exterior wall. Eave protection is often a waterproof rubberized asphalt membrane. In extreme climates, metal roofing is sometimes used on the lower part of the roof. The metal is watertight and allows snow and ice to slide off the roof. A metal or vinyl drip edge flashing will help protect the lower edge of the roof sheathing and direct water into the gutter. A metal or vinyl drip edge flashing will help protect the lower edge of the roof sheathing and direct water into the gutter.

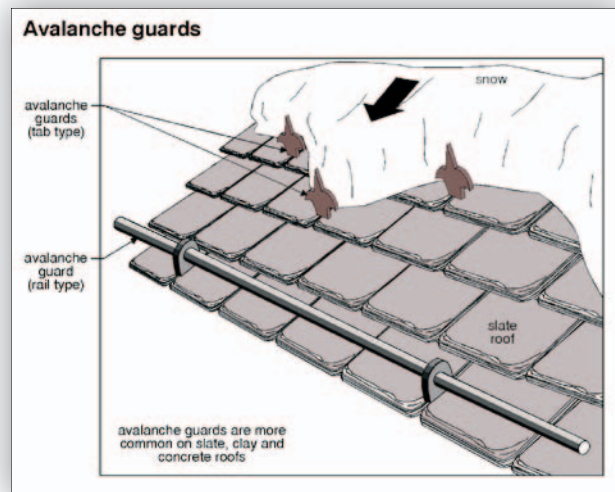
AVALANCHE GUARDS Small metal devices that protrude above roof surfaces (usually on the lower section of roof) are designed to hold snow on the roof and prevent avalanches. These are common on slate roofs and larger homes and commercial buildings. Some say these may worsen ice-damming conditions.

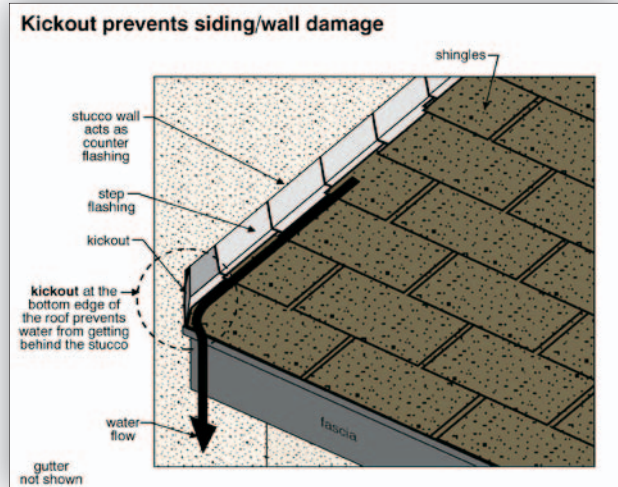
NO KICKOUT FLASHING This flashing should be provided at the bottom of the roof that is against the side wall. Where the flashing is omitted, water may get in behind the siding and cause damage to the wall around and below the bottom of the roof.

We looked at kickout flashings on Page 19.

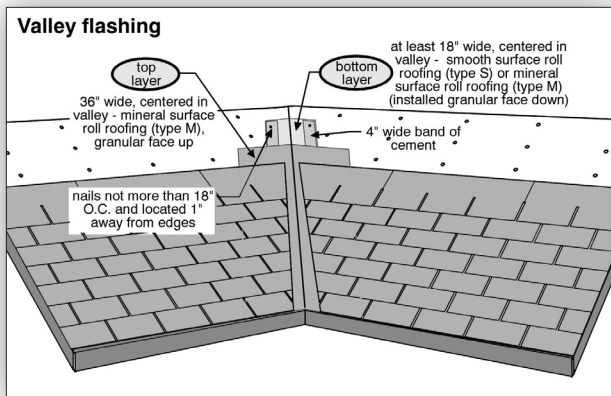
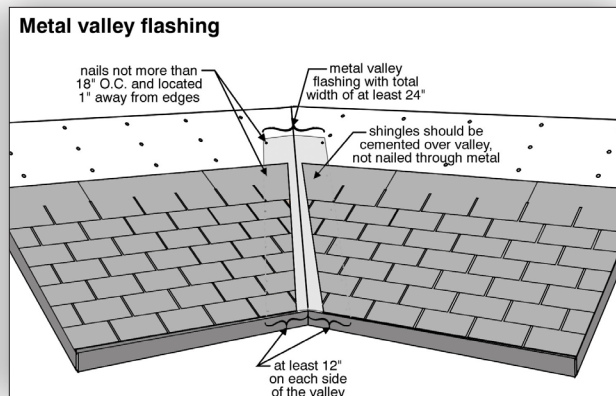
DESCRIPTION All valleys should have flashings. Metal valley flashings are better but more expensive than roll roofing. Where the flashing is visible, it is known as an open valley. Metal valley flashings are typically 24 inches wide; however, much of the material is hidden by the shingles. When roll roofing is used, two layers are installed; one being 18 inches wide, and the top one 36 inches wide.

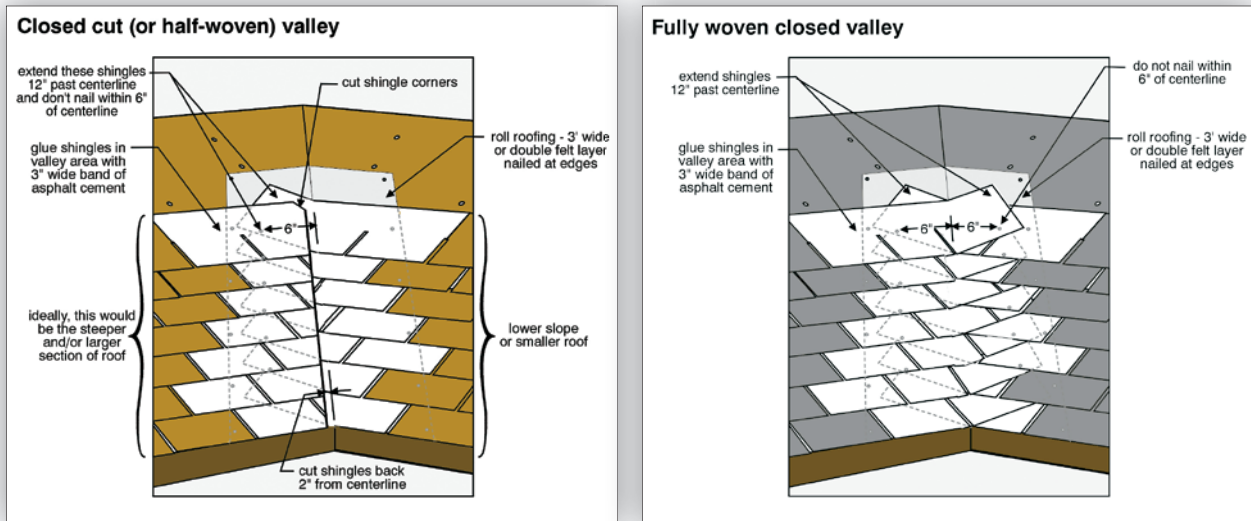
Sometimes a valley flashing is installed and then covered with shingles. This is called a closed valley. These may be closed cut or fully woven.

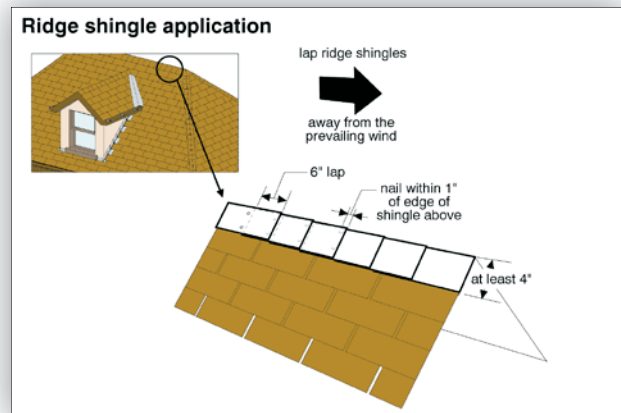
DESCRIPTION Flexible shingles (such as asphalt) are simply cut and bent over hips and ridges to make them watertight. Metal flashings are often used with brittle roofing materials (wood shingles, slate, and asbestos cement) at the ridges and hips. Flashings may also be made from the roofing material. On some roofs, the flashing is covered by a layer of shingles.

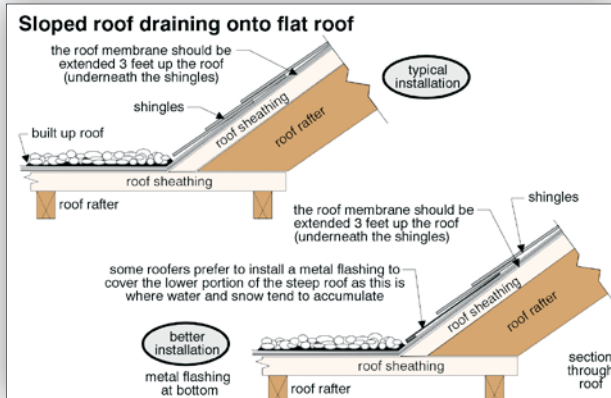
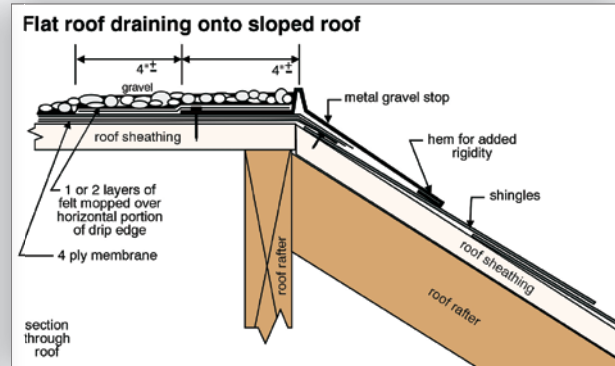
DESCRIPTION When the flat roof is below the sloped one, the flat roofing material is typically applied first and extended up the slope. The sloped roofing covers the flat membrane. There may be metal flashing used at the change in direction. When the flat roof is above the sloped roof, a metal flashing protects the top of the sloped roofing material. The metal flashing extends onto the flat roof and is covered by the flat roof membrane.

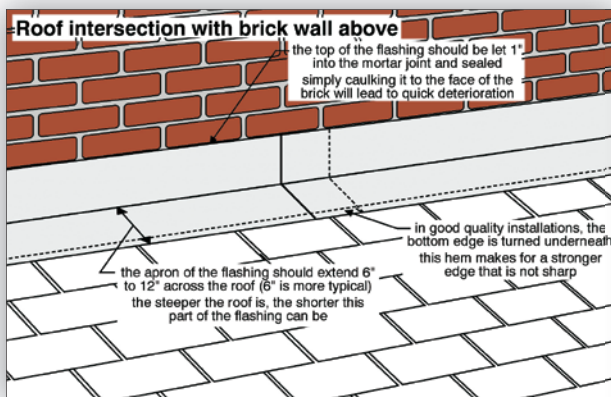
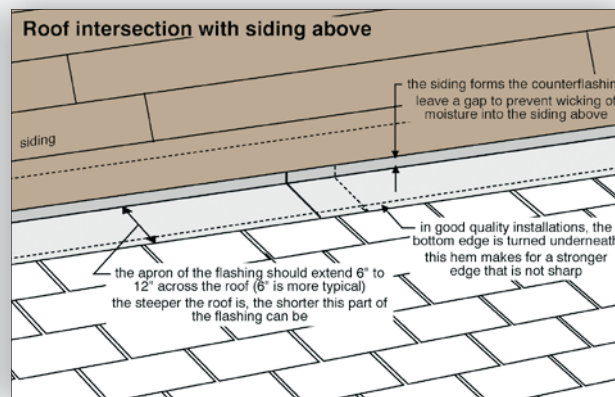
DESCRIPTION Special flashing is used when a roof intersects a wall. The flashing depends on the configuration and the roofing material. If the top of the roof meets a wall, a counter flashing can be installed over the roofing material. This metal skirt covers the top of the roofing material and extends up the wall behind the siding. On masonry walls, the metal flashing is let (embedded) into a mortar joint or sealed to the masonry surface with caulking (the less desirable approach).

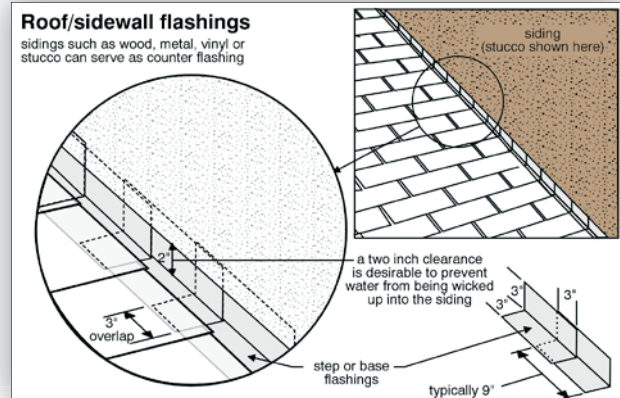
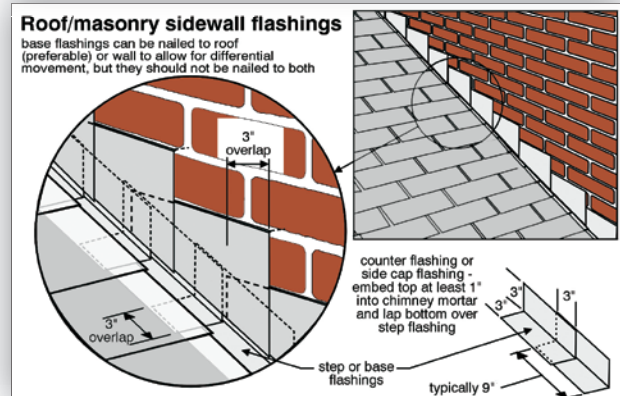
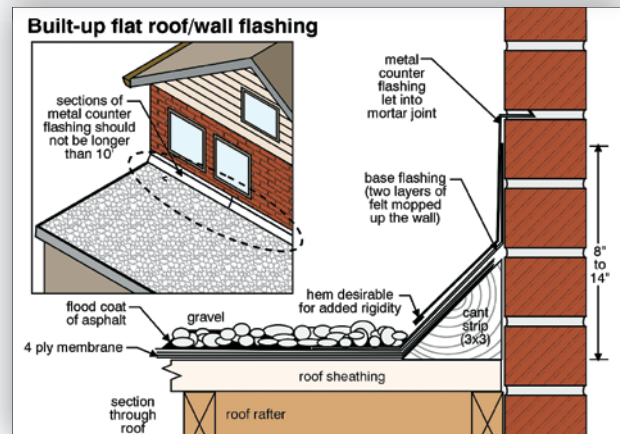
When the side of a roof ends at a wall, two sets of flashings are used. L-shaped step flashings are installed between each layer of shingles. The vertical part extends up the wall and is covered by siding or a metal counter flashing. Counter flashings are used on masonry walls, and the top may be let into mortar joints or sealed to the face of the masonry with caulking (a less permanent approach).

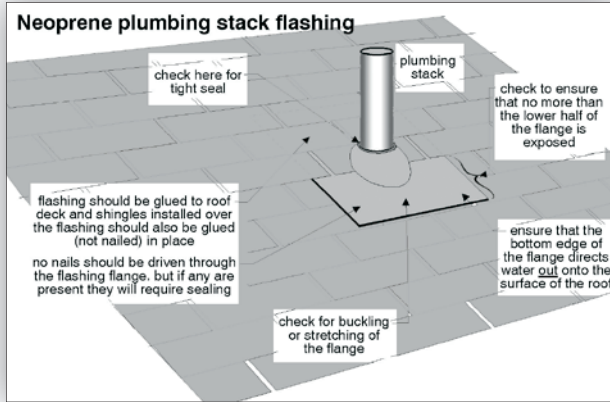
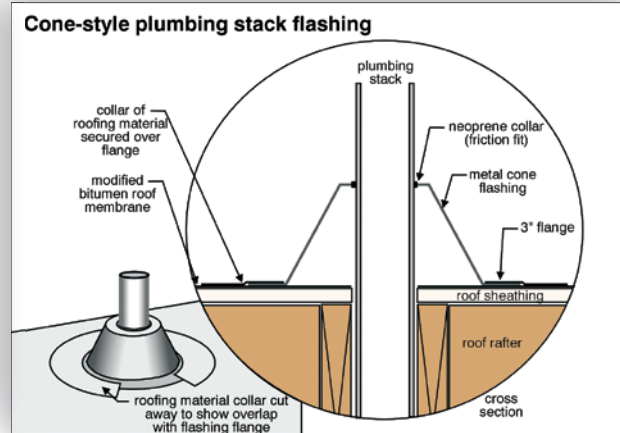
DESCRIPTION A metal or rubber flashing is provided where anything penetrates the roof.

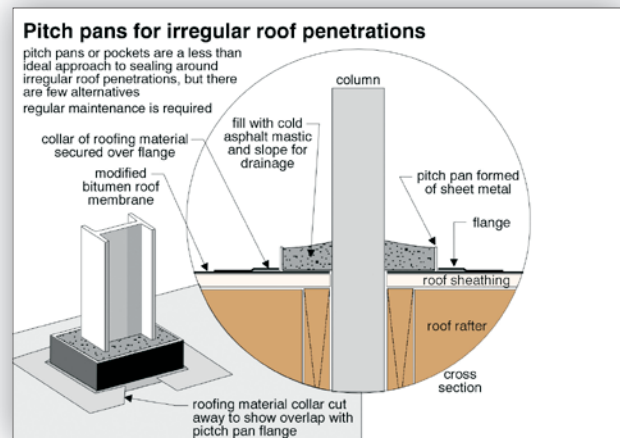
PITCH PANS (PITCH POCKETS) On flat asphalt roofs, pitch pans are sometimes used. A sheet metal pan around the stack or mast is filled with pitch or tar to a depth of one or two inches. Some experts consider this a poor flashing.

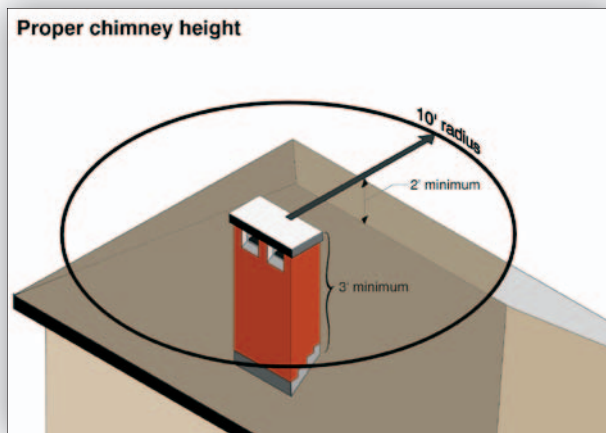
MUTUAL CHIMNEYS Many attached and row houses share chimneys. One chimney may have one or more flues for each house. Prior to working on a mutual chimney, co-ordination with the neighbor makes sense. Shared flues present a safety concern. This is discussed in the Interior chapter.
